ECBC-TR-797

**HAZARDOUS WASTE REMOVAL OPERATIONS
CONDUCTED IN SUPPORT
OF THE BZ AGENT/MUNITIONS DISPOSAL FACILITY
REMEDiation PROJECT**

September 2010

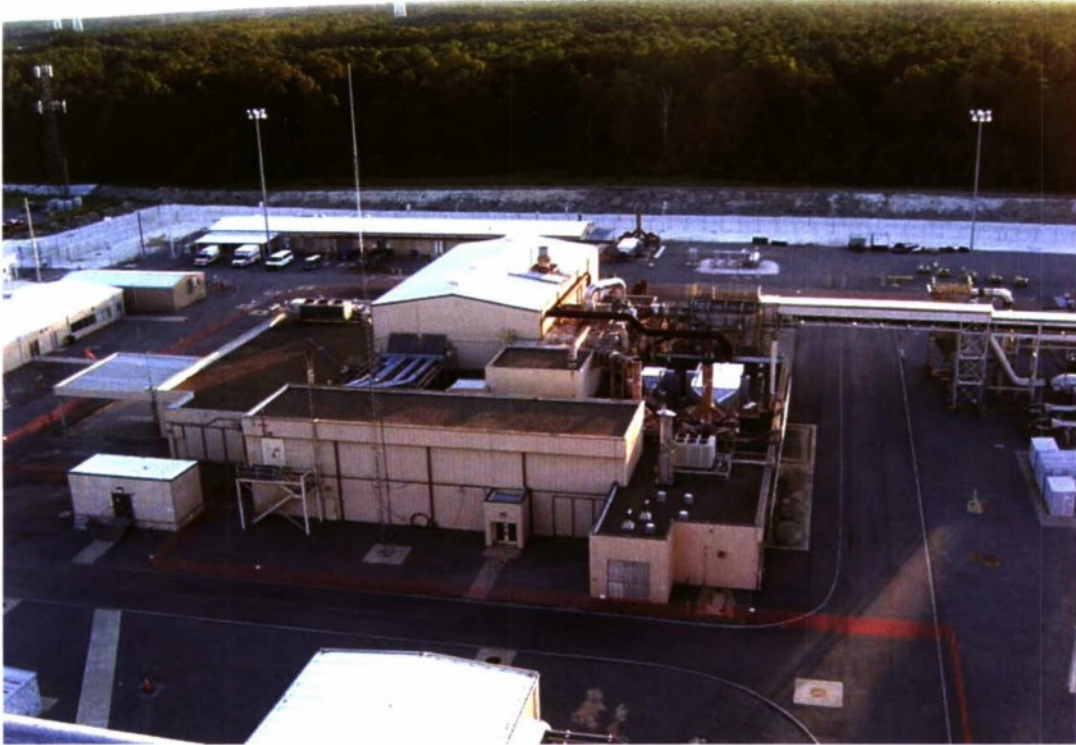
Figure 1. BZDF Facility

The BZDF (Figure 1) was constructed for the safe disposal of a munitions stockpile containing 3-quinuclidinyl benzilate (BZ). The BZDF operated for approximately 18 months and ceased agent destruction operations in 1990. The BZDF was Resource Conservation and Recovery Act (RCRA) clean closed by the Pine Bluff Arsenal (PBA) as determined by the Arkansas Department Pollution Control and Ecology (ADPC&E) (now referred to as the Arkansas Department of Environmental Quality [ADEQ]) Hazardous Waste Division on August 20, 1990. The BZDF destroyed BZ in the form of munitions, powdered agent in drums, and liquid agent in drums. These different forms of BZ were demilitarized by separate processes during operations. Munitions were processed by means of an autoclave that was used to inert the BZ fill and explosives. These munitions were then sent to a Deactivation Furnace System (DFS), where the munitions were heated to 1,000 °F for a specified period of time. The residues from this operation were processed through the Heated Discharge Conveyor (HDC).

BZ liquid drums were processed in Metal Parts Furnace (MPF) #1 and #2. The liquids were evaporated in the furnaces and the vapors were combusted in the primary fume burners above the furnaces to destroy the BZ. MPF #3 and #4 were used to destroy the materials and secondary wastes from unpacking munitions and contaminated materials from BZ processing. A Common Afterburner (AFB) and Pollution Control System (PCS) handled the combustion gases from all six BZDF incinerators. Drums containing BZ agent in the form of powder were processed through the Liquid Incinerator (LIN). The powder was mixed into slurry with acetic acid and pumped into the incinerator, where the BZ was destroyed.

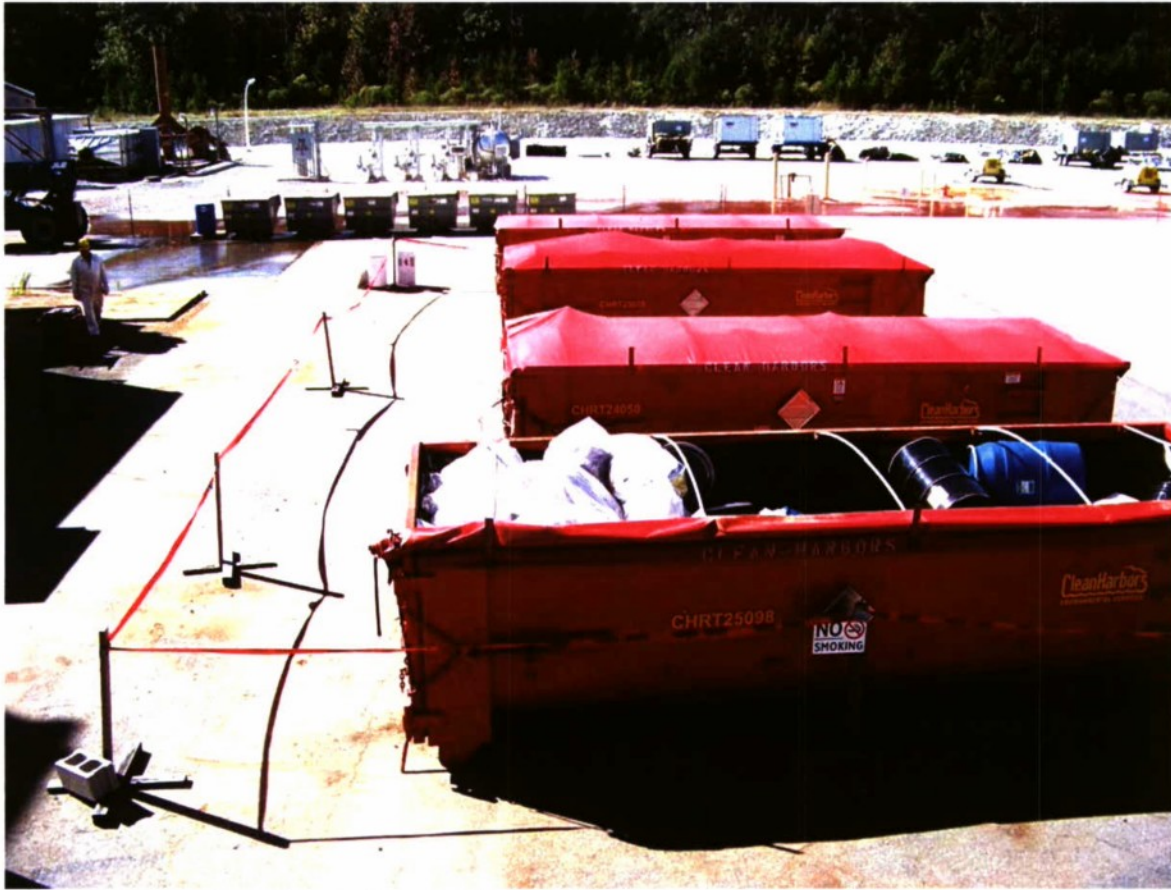
Figure 2. Hazardous Waste Disposal Roll-off Containers

This refractory brick, slag, and/or ash waste was removed by ECBC during remediation operations and placed into lined roll-off containers (Figure 2) that were labeled in accordance with the management practices listed in the ECBC BZDF Waste Management Plan. The accumulation start date began with the day that waste material was first placed into the container; although waste material was continually added until the container was full. The area was inspected daily and documented on the ECBC 90-Day Hazardous Waste Area Inspection Form. A total of three roll-off containers were used to contain the waste generated from the removal of material from the remediation of the BZDF furnaces, Common AFB, PCS, and associated ducting.

The roll-off boxes used to contain the ash, brick, and slag from remediation activities were removed from the BZDF on November 11, 2008. This material was transported to Clean Harbors Lone Mountain Facility in Waynoka, OK. The material was removed from the roll-off containers, where it was prepared for macro encapsulation at Clean Harbors Landfill. A Certificate of Disposal was generated and provided to ECBC on December 2, 2009.

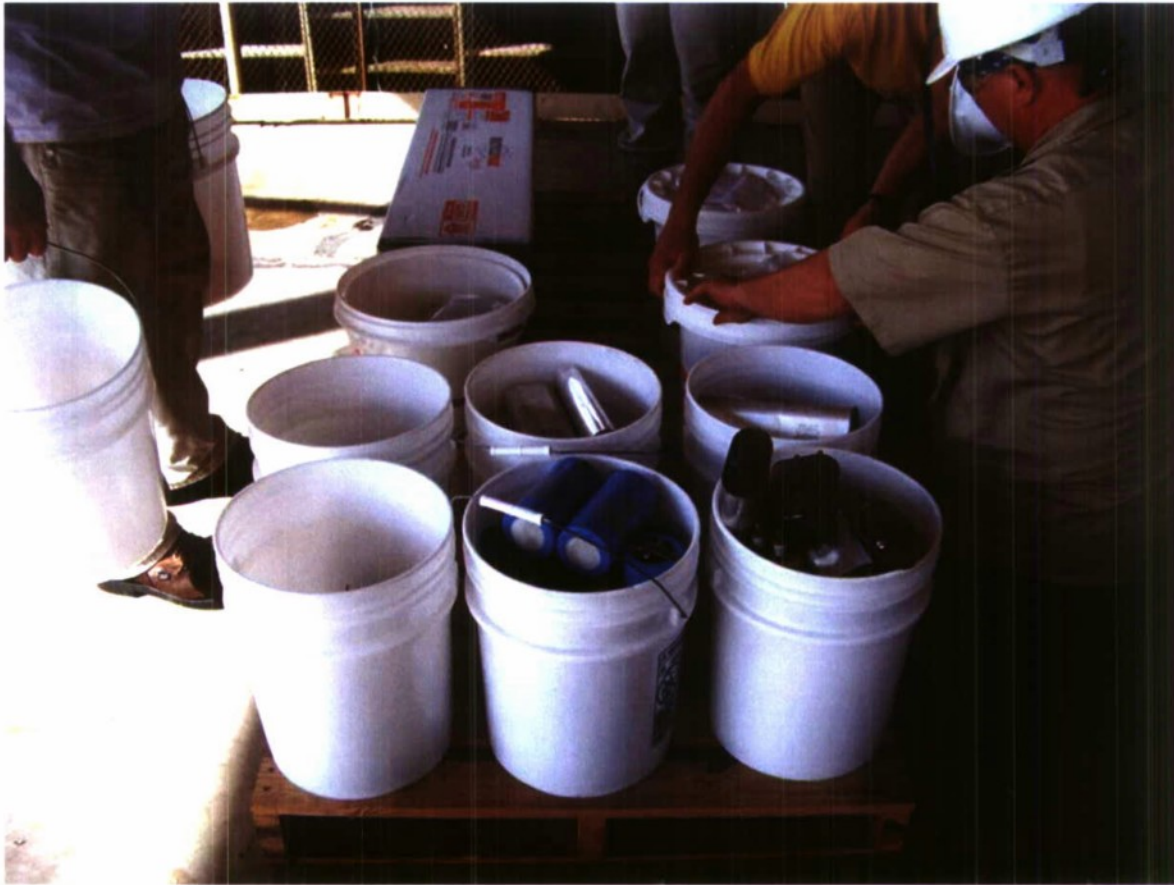
Figure 3. Hazardous Waste Segregation

Universal wastes were generated as part of the remediation process at the BZDF. Fluorescent light bulbs, lead acid batteries, nickel cadmium batteries, and mercury ampoules from vacuum gauges were collected throughout the BZDF. These materials were properly identified, labeled, and managed in <90 day hazardous waste storage areas designed by URS (Figure 3). Leaking batteries and broken fluorescent bulbs were labeled as hazardous waste and managed accordingly.

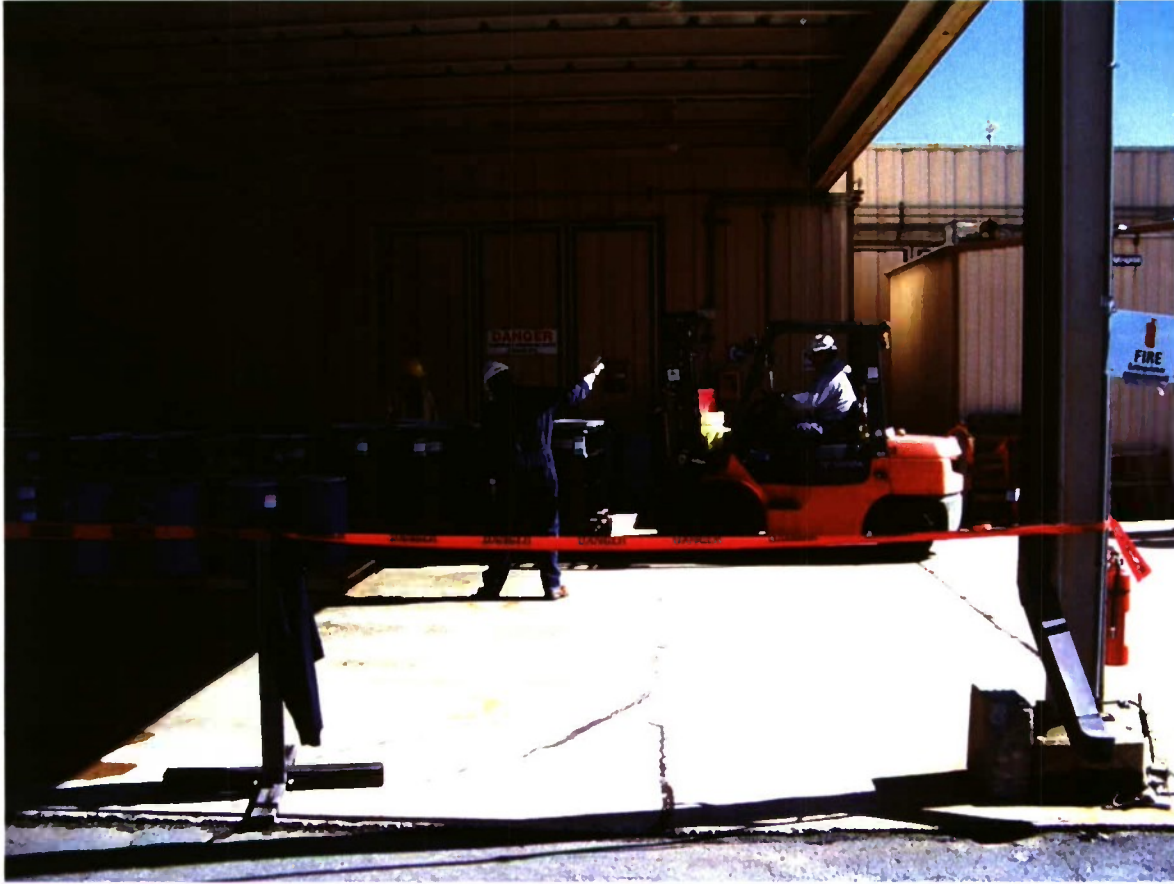
Figure 4. <90 Day Hazardous Waste Storage Site

Good housekeeping practices were followed, as seen in Figure 4, to ensure the waste storage areas were easily accessible and unobstructed so that activities could be conducted safely. Containers were clearly labeled, the contents easily identified, and minimum aisle space was maintained to ensure wastes were stored correctly. All applicable waste storage regulations were followed to ensure that the areas met the

requirements in the ECBC BZDF Waste Management Plan, PBCDF waste management expectations, and all state and federal regulations.

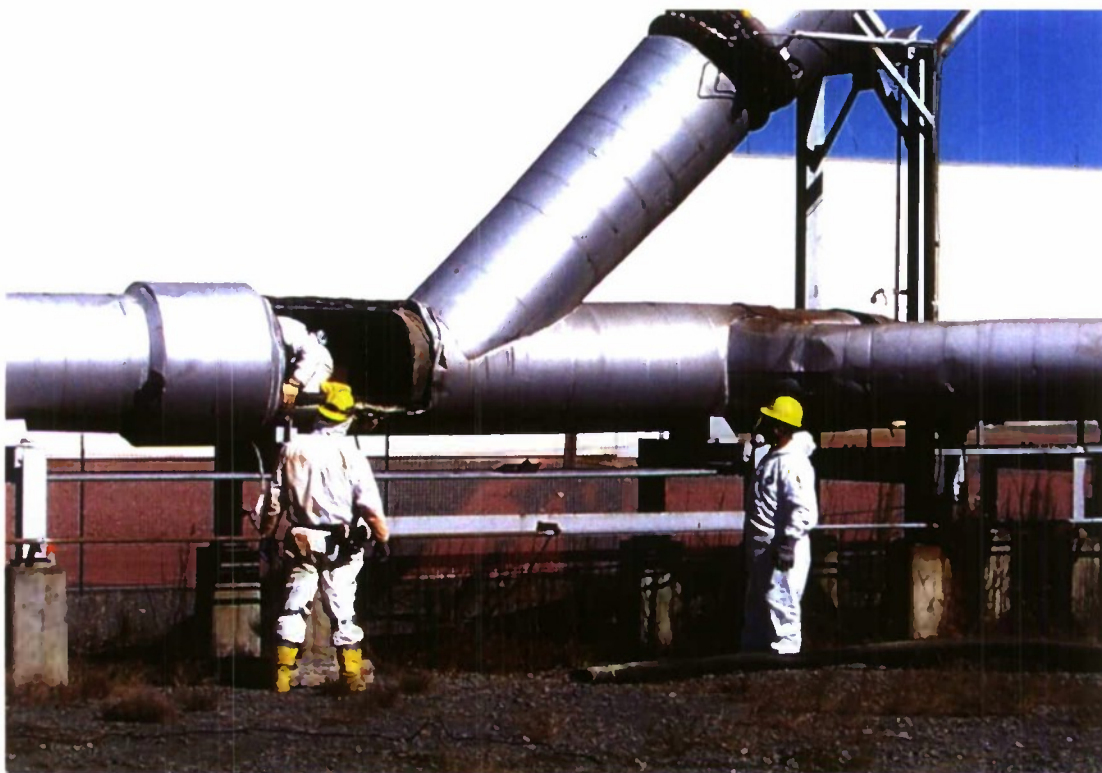
Figure 5. Hazard Waste Remediation of Pollution Control System Ducting

The Common AFB, exterior to Building 57-110 (which housed the furnaces), was disassembled as necessary to remove all refractory and ash that had Toxic Characteristic Leachate Procedure (TCLP) metals above the regulatory thresholds. The Pollution Control System (PCS) and associated ducting was also cleared of all material including ash, rust scaling and debris that exhibited TCLP metals concentrations above regulatory limits.

Specific BZDF areas for potential remediation were identified as the Drum Preparation Area, Equipment Room #1, MDA, MUA, MIN, Fire Water System, Toxic Change Area, MPF, HDC, DFS, Common AFB, LIN, Chemical Distribution System, Support Area, Control Room, BZDF Roof, Sample Enclosure 1, Sample Enclosure 2, and PCS (including associated ducting, Figure 5). See Figure 6 for the layout of Building 57-110.

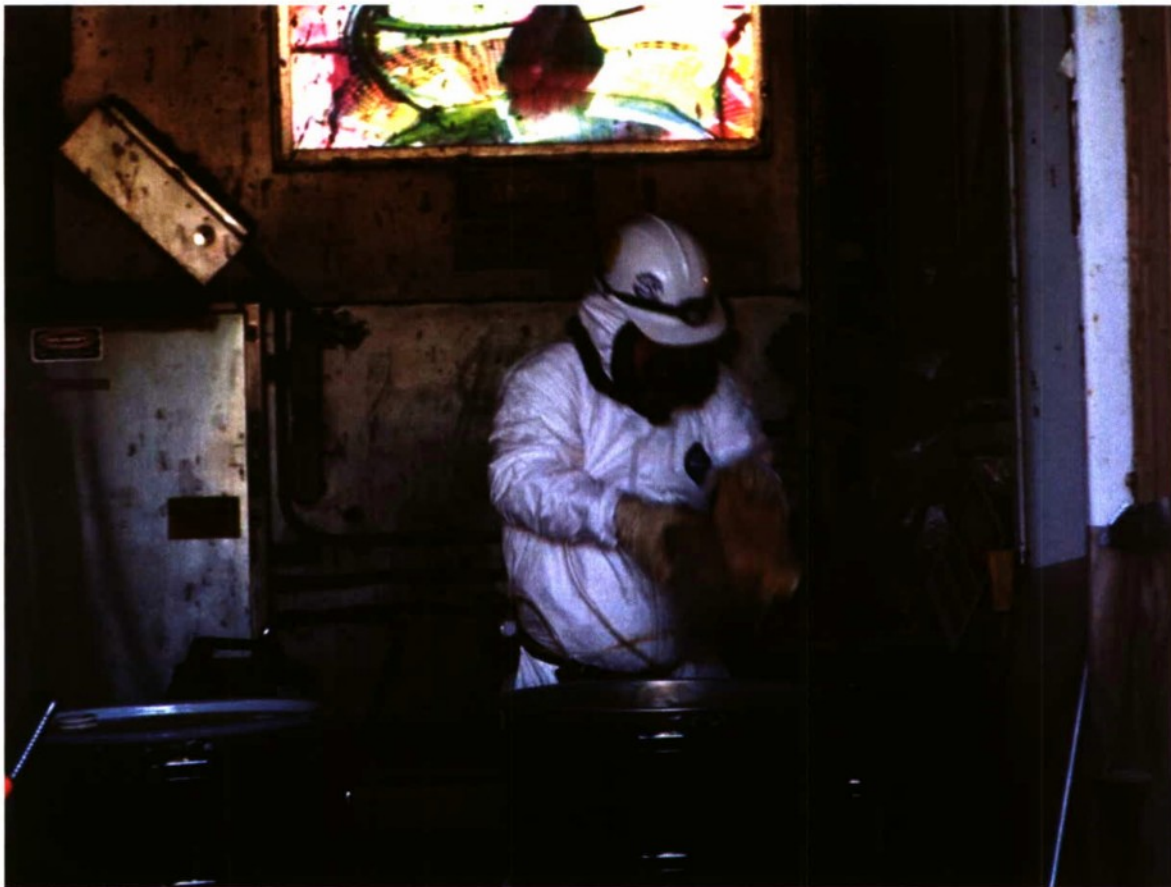
Figure 7. Contaminated Refractory Removal

A survey team performed inspections of each designated section of the BZDF identifying all suspected hazardous waste to be removed (i.e., mercury gauges, lead components, leaking batteries, smoke detectors, ash, refractory, petroleum products, etc.). Areas that were suspected for heavy metals were sampled and analyzed to determine contamination levels. The sampling results can be found in the BZDF Remediation Project Final Sampling Report. Remediation was achieved by physically removing the items of concern (Figure 7). Removal operations consisted of demolition of equipment, vacuuming debris (Figure 8), and/or draining or pumping out hazardous liquids. All operations were completed by section to ensure the safety of all remediation personnel. In areas that were contaminated with heavy metals, post remediation samples were collected to confirm clearance below EPA TCLP thresholds. If levels were found to be above EPA standards, then ECBC continued remediation work of the equipment and/or area in suspect. After post remediation sampling was completed in each section, a review of sampling results and visual inspection were performed by ECBC and WDC. The inspection was documented and signed off on by both parties to finalize remediation activities for hazardous waste.

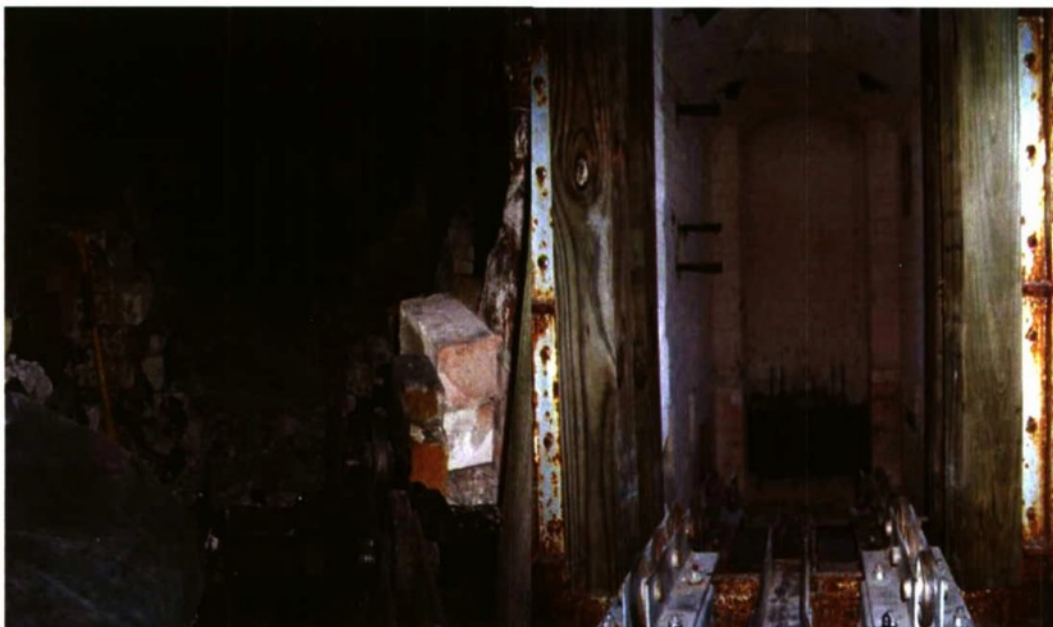
Before

After

Figure 8. Pictures of Metal Parts Furnace Remediation
